Analysis & Dashboard Report

PDI GADDI

VOLKSWAGEN JETTA COMFORTLINE MT DIESEL

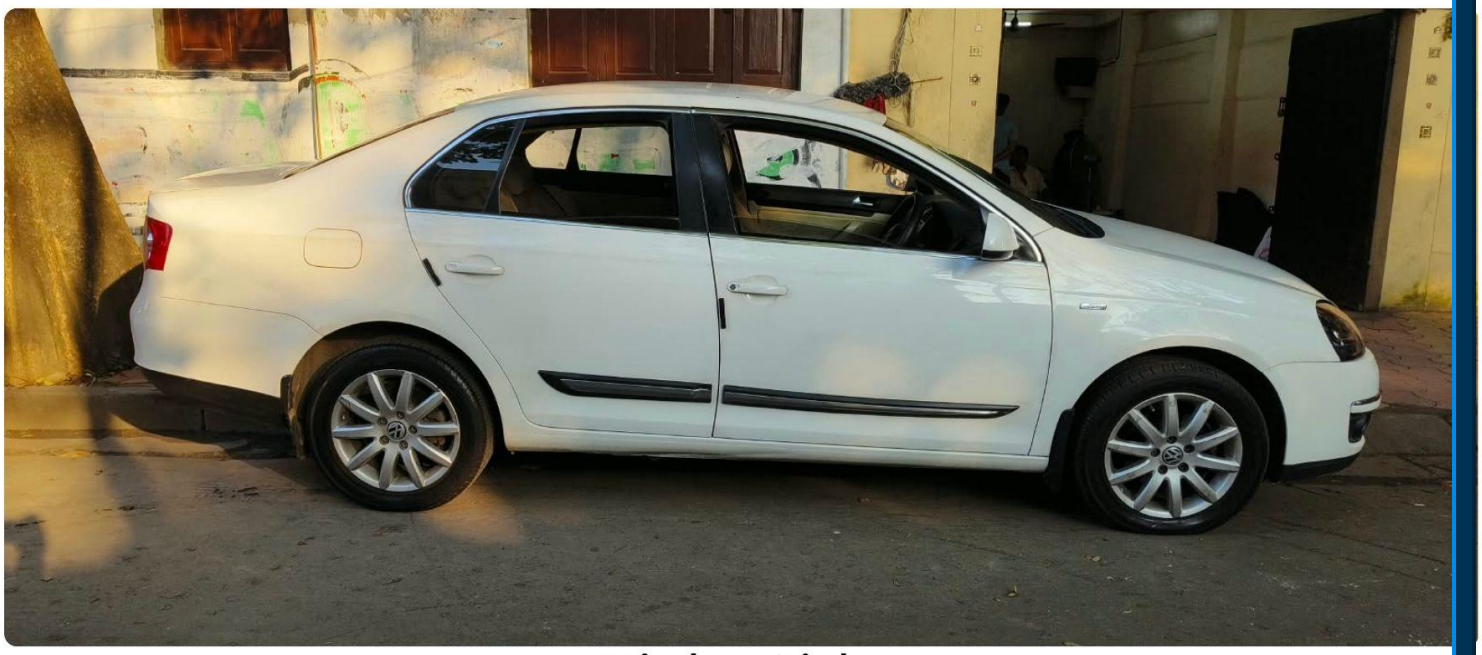
Front view

Rear View

Left side quater view

Right side quater view
